Manhole Inspection Summary

Manhole # **S39CC_023MH**

Insp Date: **10/23/07 11:45 AM**

Location Address: **936 EAGER ST**

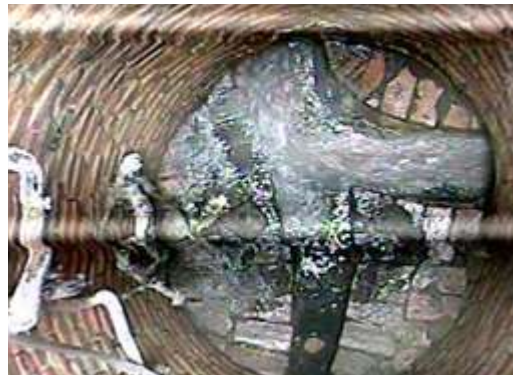
Defect 1

Count: **5** Missing: **1** ☒ **Corroded**

☒ **Evidence Of Surcharge** Depth: **2** (ft.) ☐ Active Surcharge Present

CORRODED STEPS AND EVIDENCE
OF SURCHARGE VISIBLE

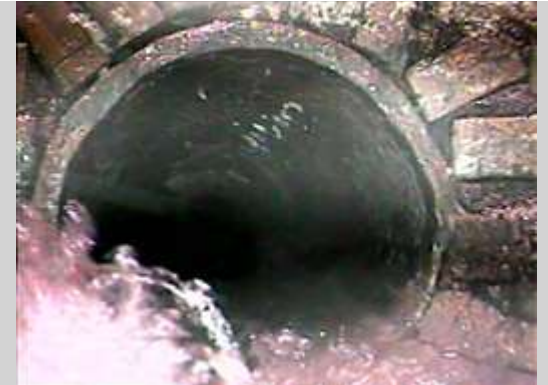
12 O'Clock Outflow

12 in. Circular Gravity Sewer
Pipe Out @ 12 O'Clock

Pipe Height: **7.2** (in.) Rod and Bar
Pipe Material: **Clay** ☐ Pipe Lined
Invert Depth: **9.77** (ft.) Flow Characteristics: **Fast**
Deposits: ☒ None ☐ Mud ☐ Sludge ☐ Debris ☐ Grease
Silt Depth: (in.) Deposits Extent:
Infiltration: **None** Pipe Seal Cond: **Sound**

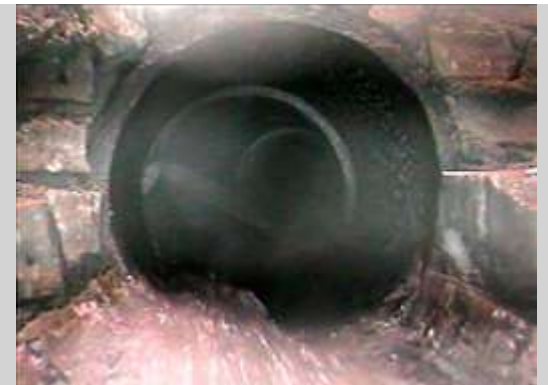
3 O'Clock Inflow

12 in. Circular Gravity Sewer
Pipe In @ 3 O'Clock

Pipe Height: (in.) Direct
Pipe Material: **Clay** ☐ Pipe Lined
Invert Depth: **9.73** (ft.) Flow Characteristics: **Fast**
Deposits: ☒ None ☐ Mud ☐ Sludge ☐ Debris ☐ Grease
Silt Depth: (in.) Deposits Extent:
Infiltration: **None** Pipe Seal Cond: **Sound**

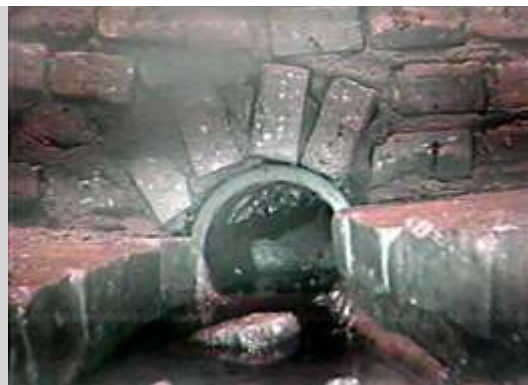
7 O'Clock Inflow

6 in. Circular Gravity Sewer
Pipe In @ 7 O'Clock

Deposits: ☐ None ☐ Mud ☐ Sludge ☐ Debris ☒ **Grease**

Silt Depth: **1** (in.) Deposits Extent: **Light**

Connects To: **Stub connection / abandoned**
